Manhole Inspection Summary

Manhole # S17AA1022MH

Insp Date: **2/28/07 9:45 AM**

Location Address: **2282 PARK HILL AVE**

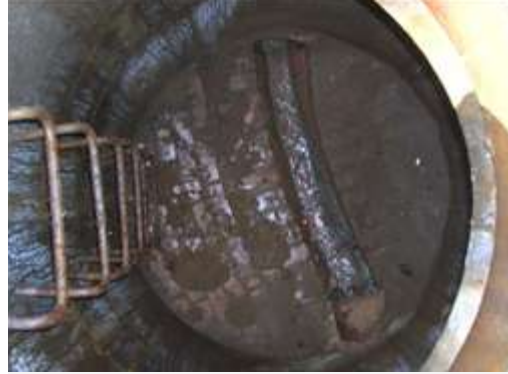
Top View

Corroded steps. Evidence of surcharge - Bench debris.

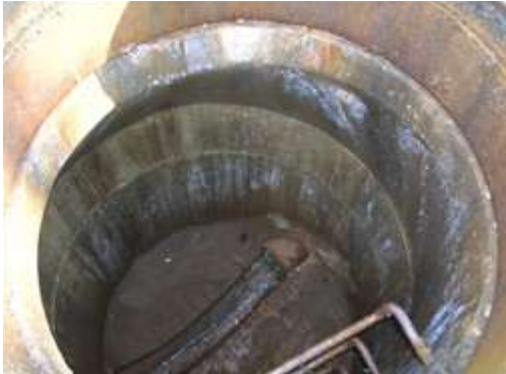
Defect

Frame leaks. Adjustment infiltration

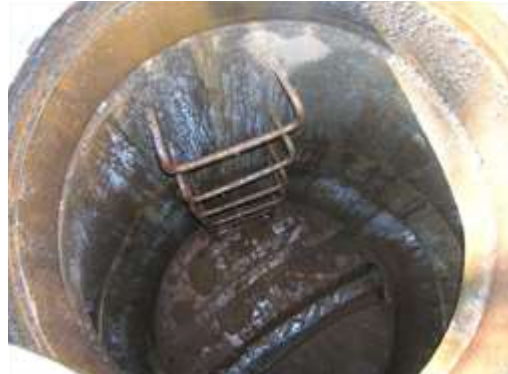
Defect

Frame leaks. Adjustment infiltration.

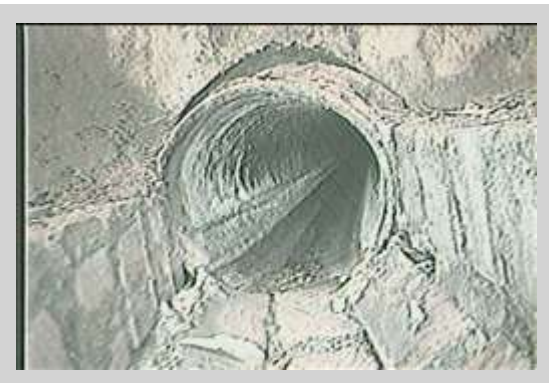
8 in. Circular Gravity Sewer Pipe In @ 5 O'Clock

Channel deterioration.

Deposits: ☐ None ☐ Mud ☐ Sludge ☐ Debris ☒ Grease

Infiltration: **Evidence** Pipe Seal Cond: **Unknown**
